# Massachusetts Conservation Corps:

Staff Hitch 8/31-9/7, 2020

## Mahican Mohawk Project Summary:

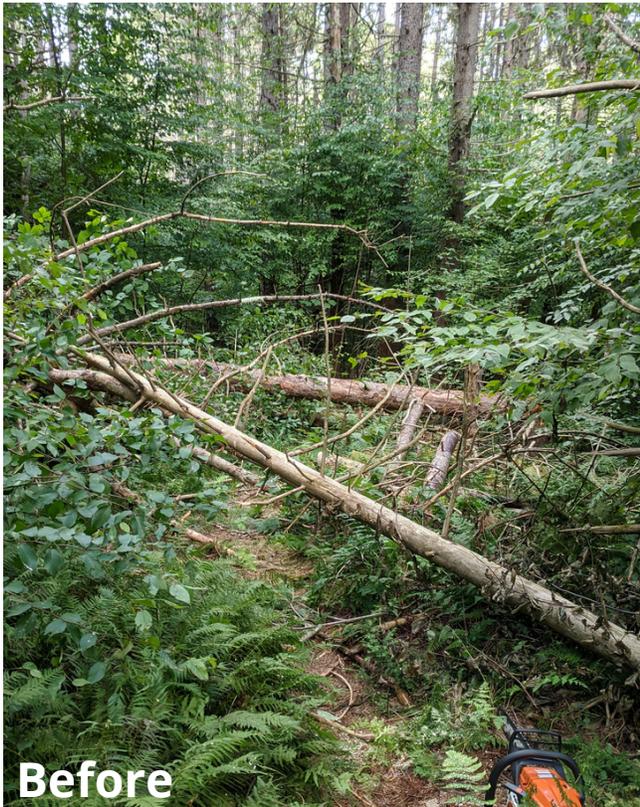
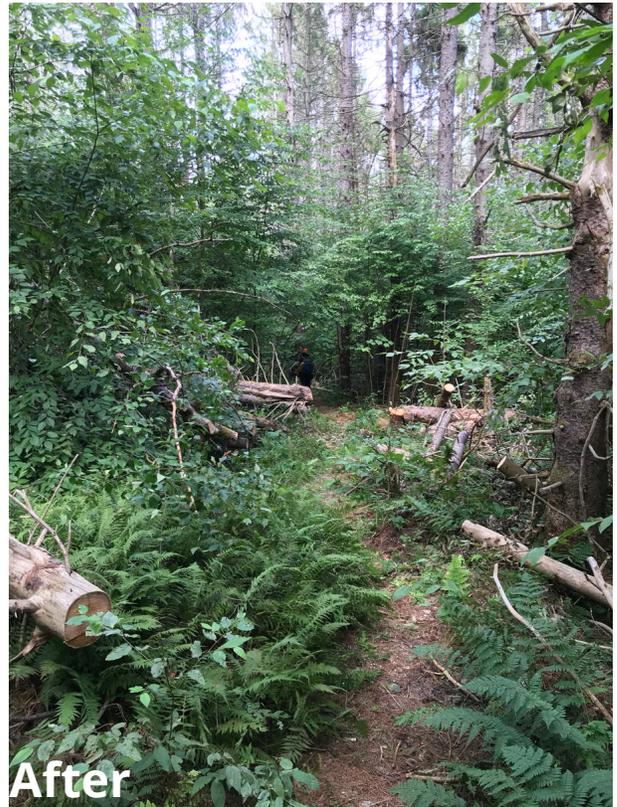
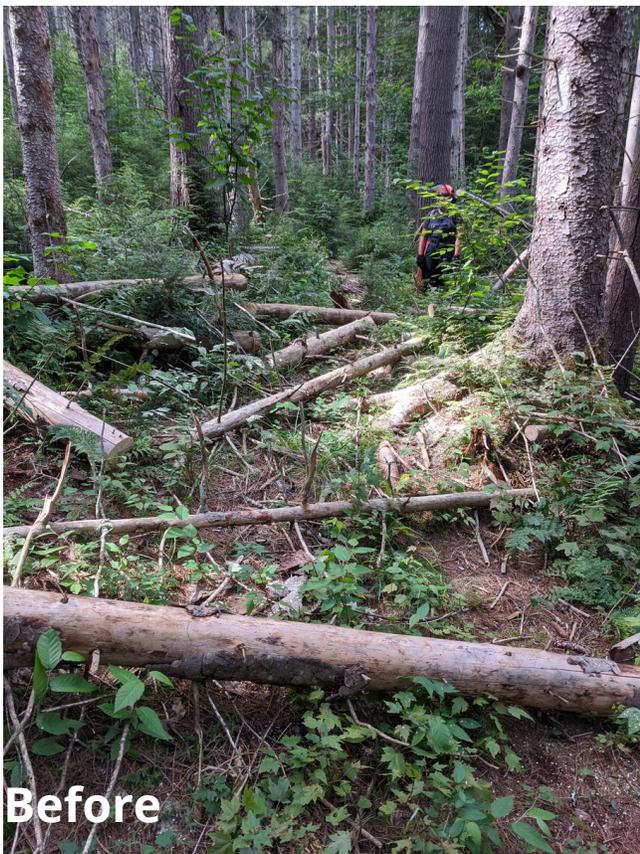
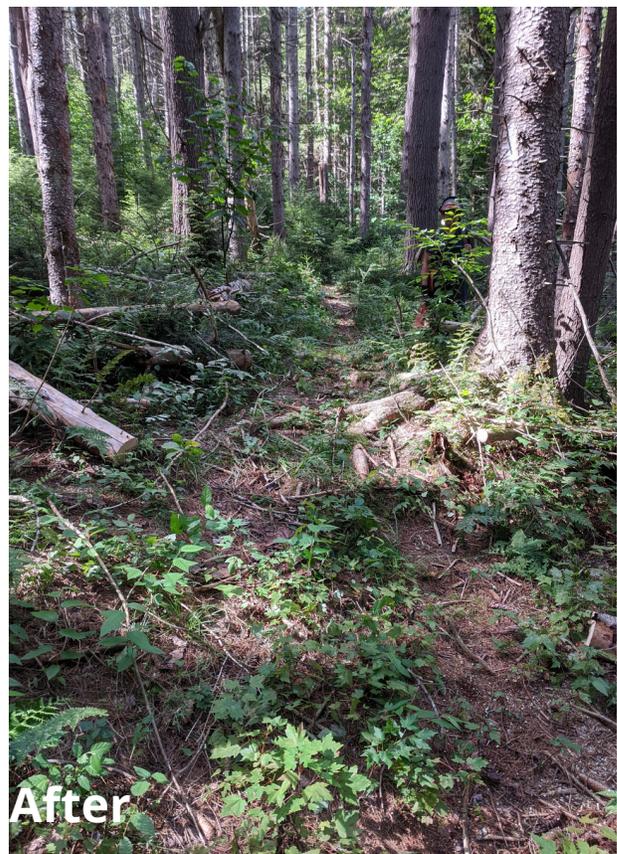
Photos from the project: Blowdown removal

This project focused on four miles of the Mahican Mohawk Trail heading east from the trail head at South County Road, over Clark Mountain, to the junction with the Indian Trail. Many sections of this trail were blocked with blown down trees. In total, the crew sawed out over 20 trees blocking the trail, which made it impassible in sections, and pulled down an additional 5 widow makers, improving hiker safety. The crew also tackled the replacement of a native timber bridge over Wheeler Brook, in a truly beautiful section of the Mohawk Trail State Forest. The bridge had failed with one stringer lying broken in the creek and the second stringer unsafe for use. The crew enjoyed the opportunity to use (and refresh) their native timber and rigging skills, while restoring safe passage over the creek.

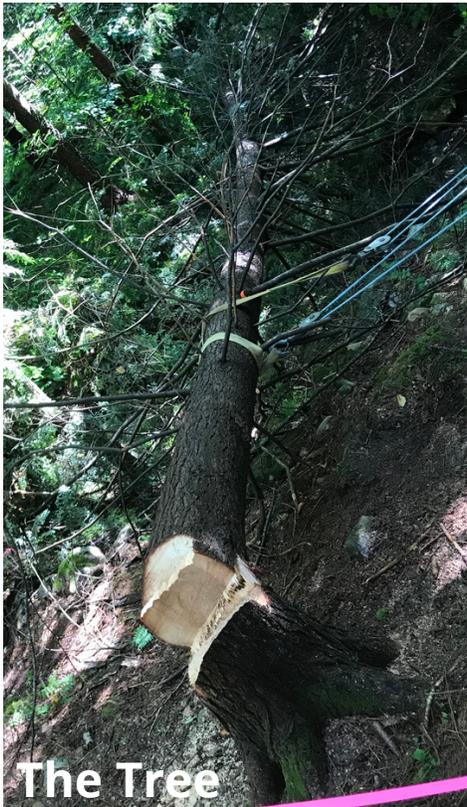
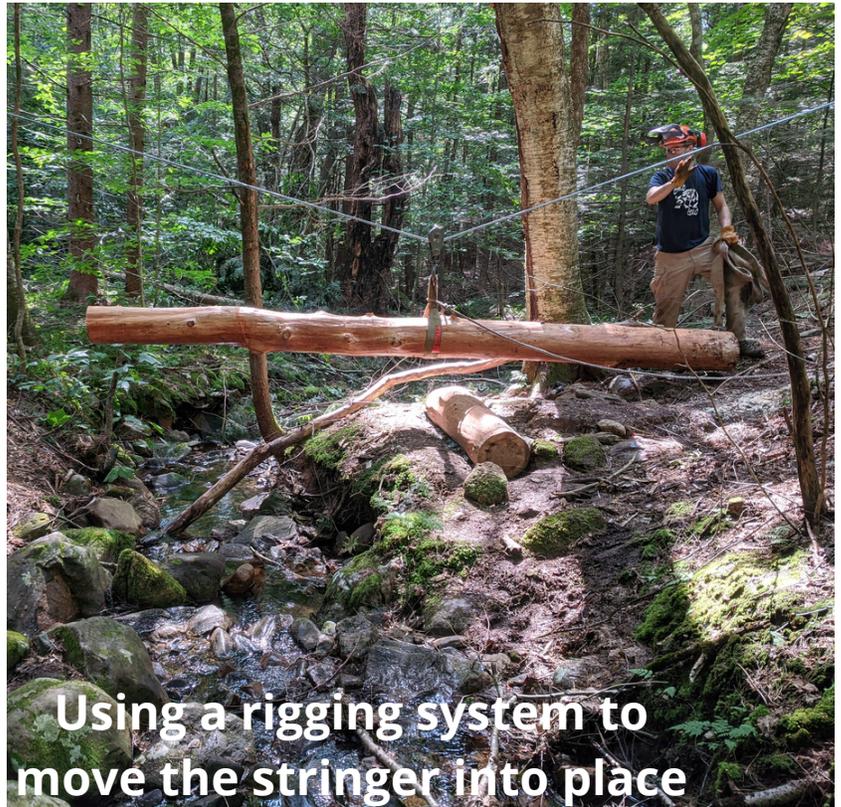
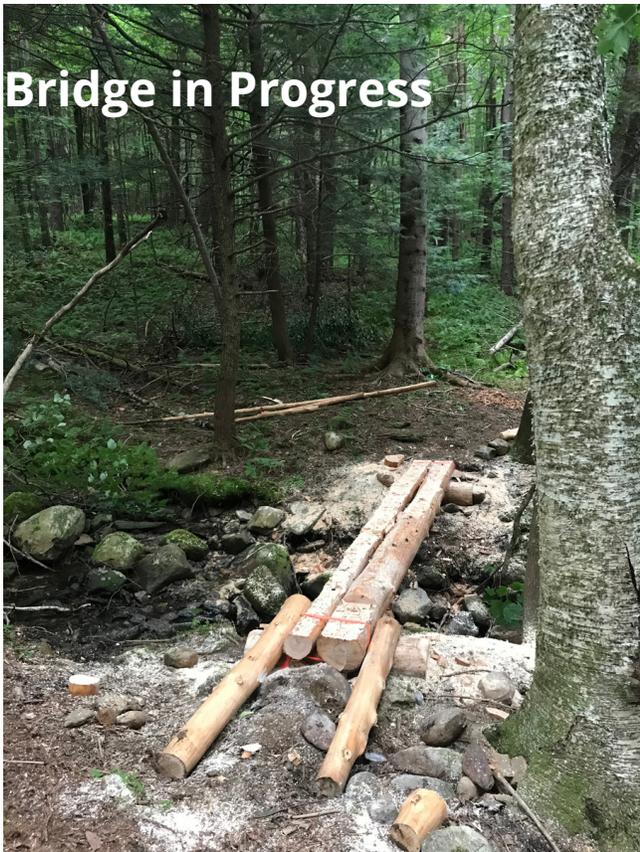
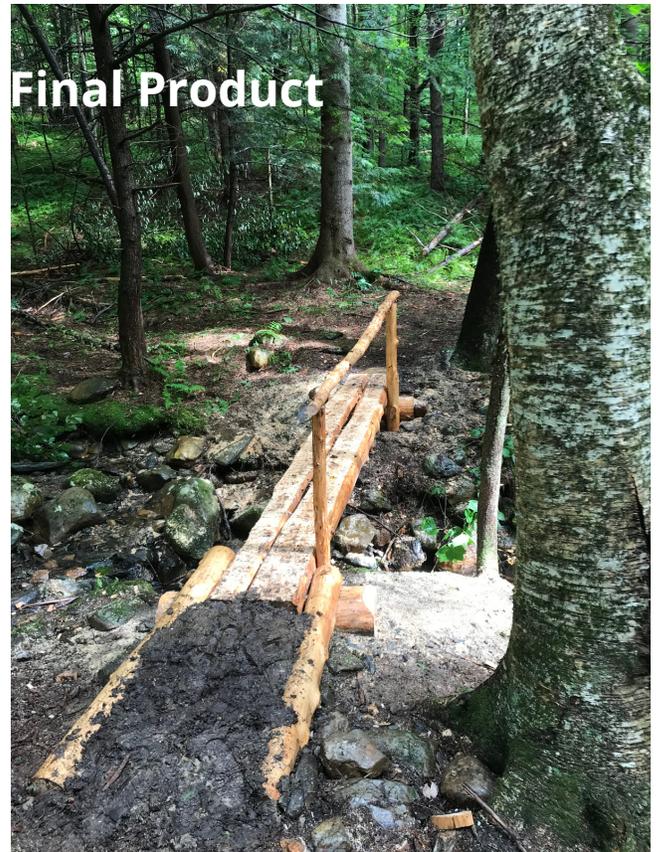
# Photos from the project: Rustic Timber Bridge

5. **COMPLETE:** This is the location of the rustic timber bridge replacement.

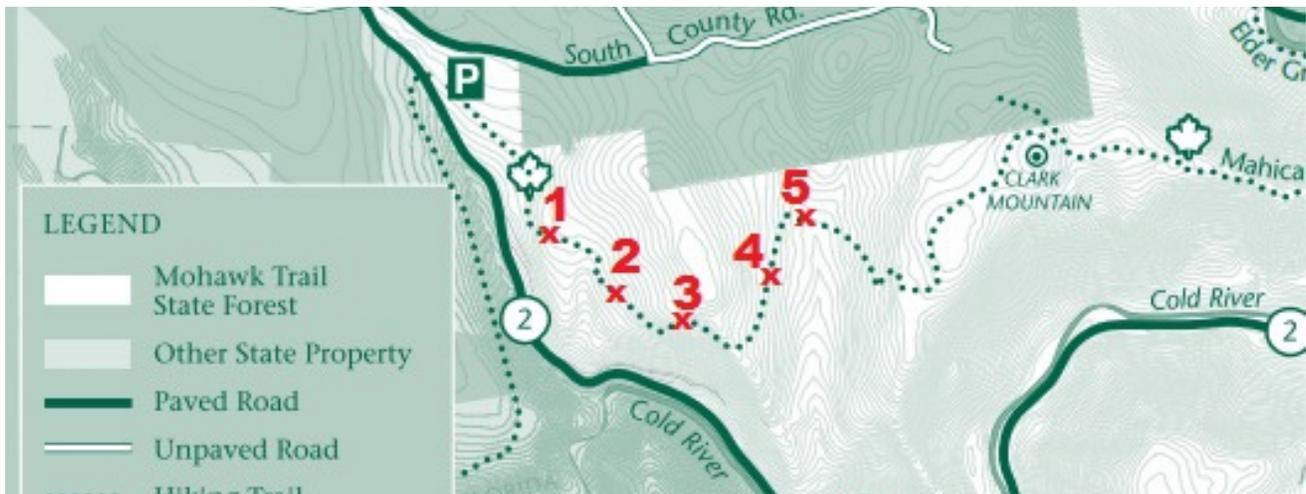
## Completed and Future Project Map

While there were significant improvements made to this section of the Mahican Mohawk Trail during this hitch, there remains more work to be done. This map shows locations of both completed work and issues that will need to be tackled in the near future.

1. **NEED:** There are 3 sets of rustic bog bridges over shallow drainages in this section that should be replaced in the next 1-2 years.
2. **NEED:** The sills of a dimensional bridge over a deep drainage are being severely undercut. Rock retaining structures could be used to reinforce the sill's or the bridge could be rebuilt with a longer span.

3. **NEED:** There is a 1/4 mile section of trail in this area with sustained steep slopes of 20-25%. While this is a rugged trail, current best practice in trail design call for 10-12% grade with short sections of 15% grade. We would recommend adding a switch back or two in this area, which will help with erosion and make the trail more user friendly

4. **COMPLETE:** This section had large clusters of trees blocking the trail. While the trail is passable now, the forest in this area has large amounts of dead pines, which will likely end up across the trail in future years.
